SPECIAL REPORT - THE USE OF SKYLAB AND ERTS IN A GEOHYDRO-  
LOGICAL STUDY OF THE PALEOZOIC SECTION, WEST-CENTRAL  
BIGHORN MOUNTAINS, WYOMING.

Barbara J. Tomes  
Department of Geology  
University of Wyoming  
Laramie, Wyoming 82071

March, 1975

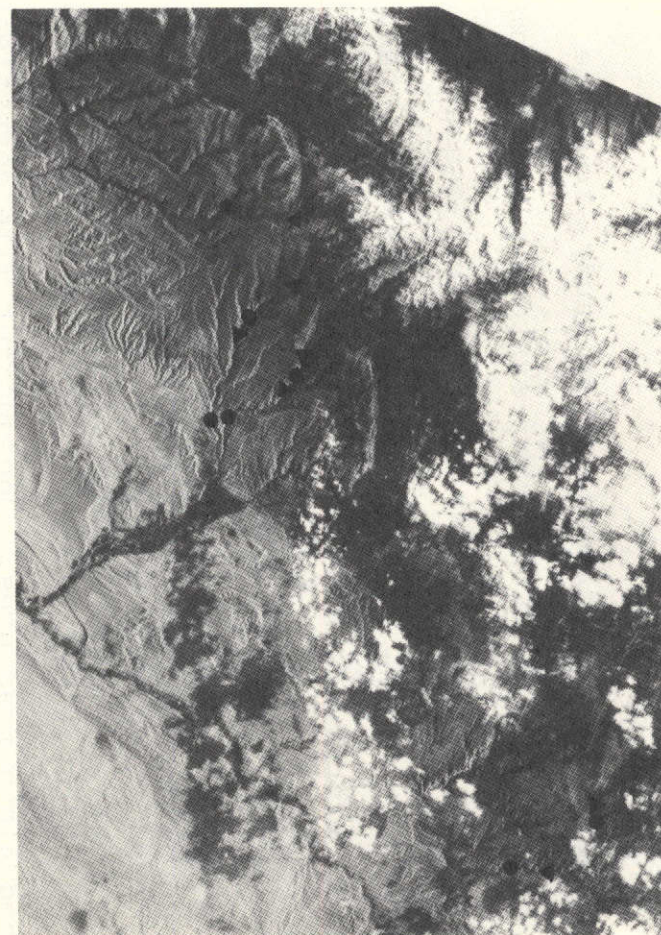
Figure 3a.

Skylab II Track 5 pass 10 S190-B photograph and ERTS-1 image 1409-17285-5 showing location of known sinks and springs on four creeks in the study area.

Paleozoic rocks cropping out in the study area include the Pennsylvanian Tensleep and Amsden formations, Mississippian Madison limestone, Ordovician Bighorn dolomite, and Cambrian Gros Ventre, Gallatin, and Flathead formations. Runoff flows from the Precambrian core of the Bighorn Mountains across the Paleozoic section and into the Bighorn Basin. Water normally carried in surface streams often sinks as it flows over the outcrops of the Bighorn dolomite, the first Paleozoic carbonate encountered in the downstream direction. Down-gradient, but up-section, a portion of the water lost to sinks reappears in springs. Known sinks and springs are located on Figures

3a and 3b. All the upstream sinks are found in the Bighorn dolomite. Springs downstream are usually found in the Madison limestone. In two cases the water sinks and rises twice in a single drainage.
